Ballistic damage of graphite-epoxy plates

BALLISTIC DAMAGE OF GRAPHITE-EPOXY PLATES

George Arthur Eaton

June 1977

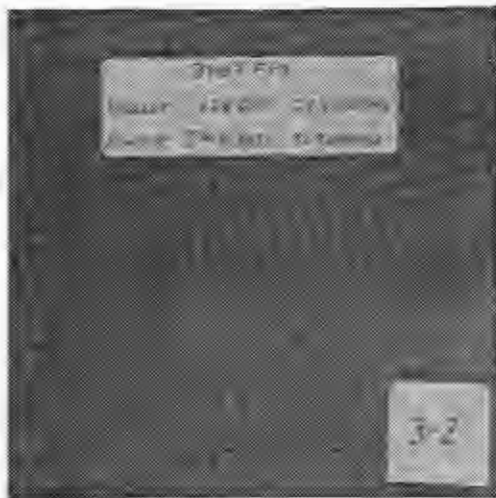
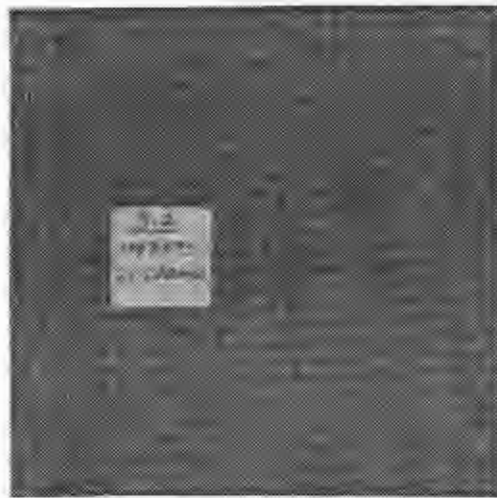
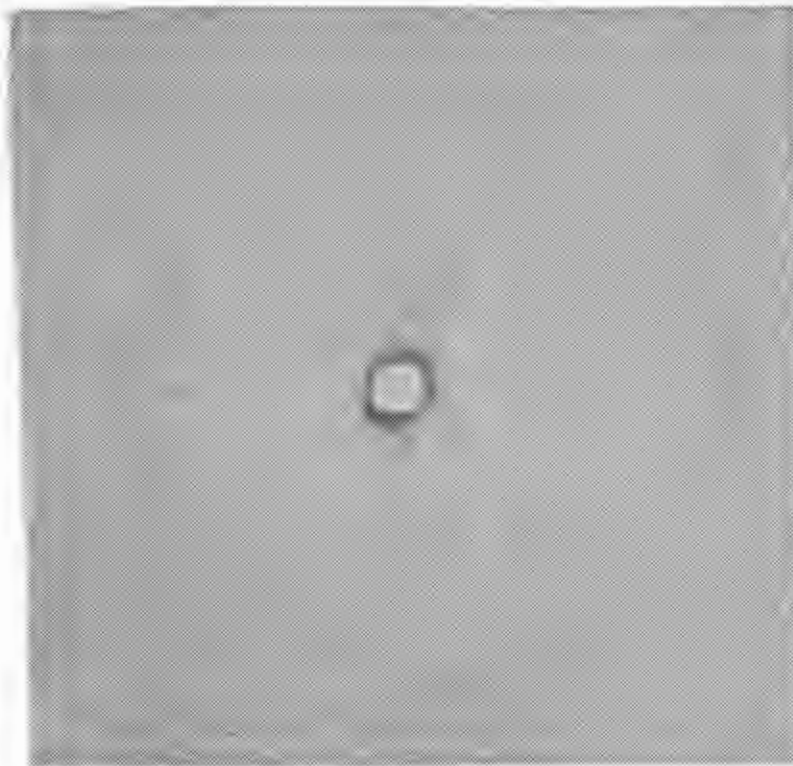
Figure 12 - COMPARISON OF X-RAY AND PHOTOGRAPH OF SPECIMEN DAMAGED AT 3407 FPS

The effect of mass variation did not appear to be a major factor in damage area or extent of fiber separation due to ballistic impact. The damage done to the specimens was nearly uniform for the three masses investigated. Figures 12, 13, and 14 depict the variable-mass specimens and the damage experienced.

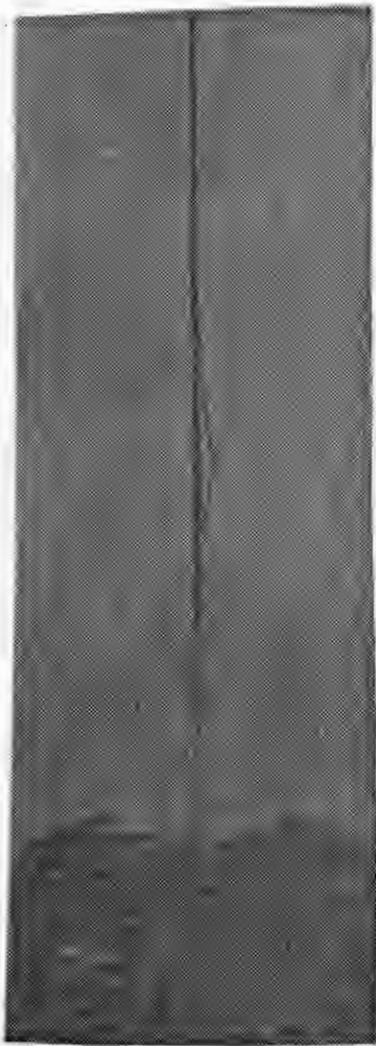
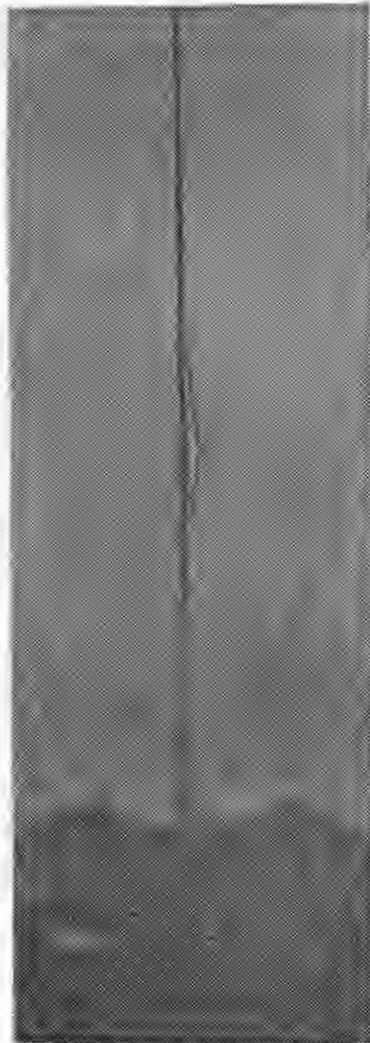
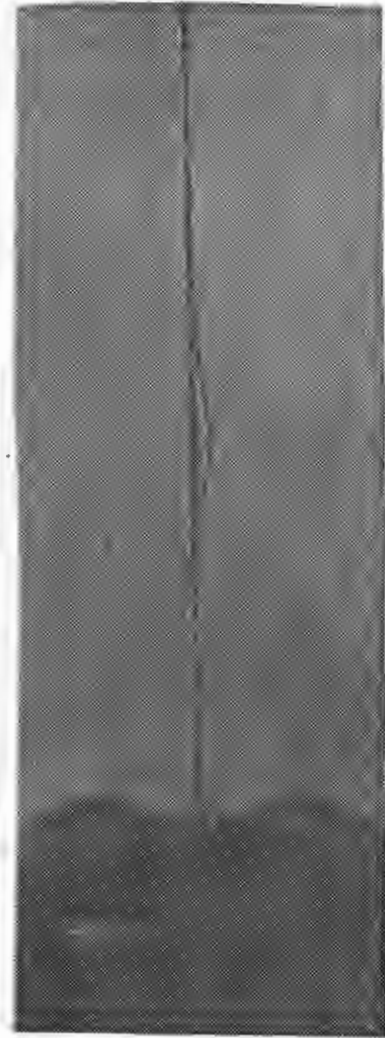
Figure 20 - TENSILE TEST LOADING-TO-FAILURE SEQUENCE

The maximum loading at failure was recorded. Figures 20, 21, and 22 illustrate the sequence of events leading to and including failure of a specimen. The outer laminae of the composite specimens (0° direction) were the only laminae that experienced this separation and protruding. The second ply (45° direction) appeared to remain intact until final failure. The three mechanically drilled control specimens also experienced this separating and protruding above and below the hole, even though they did not have any prior delamination caused by ballistic damage. As loading was applied to these specimens they reacted the same way as the ballistically damaged specimens behaved up to and including failure. The undamaged control specimens showed no sign of physical change while being loaded until they broke.

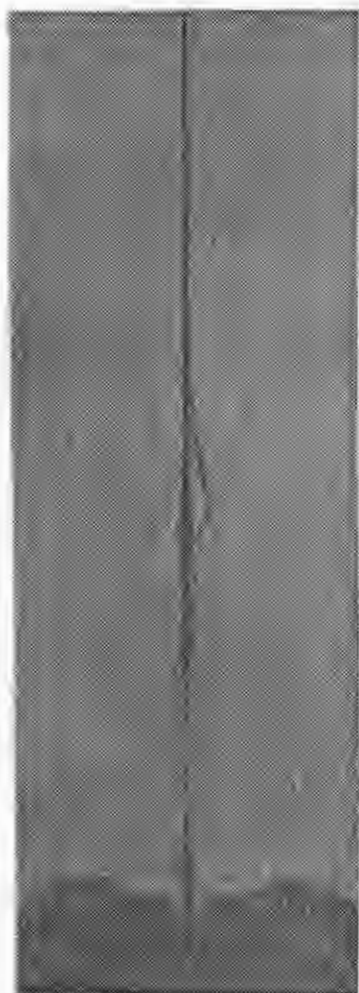
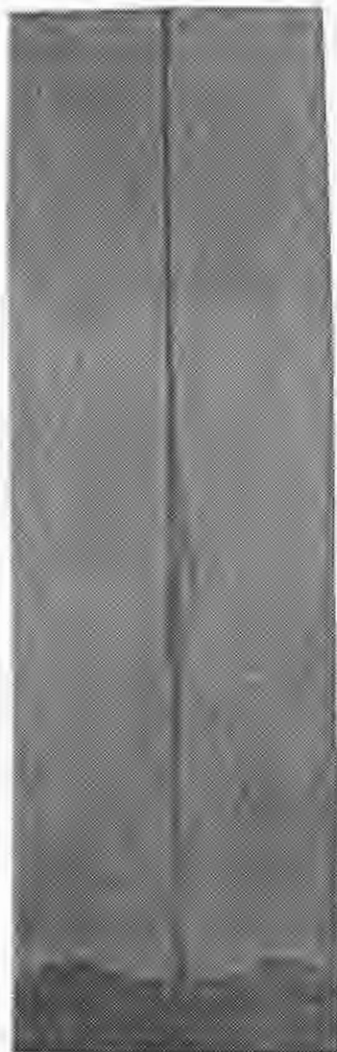
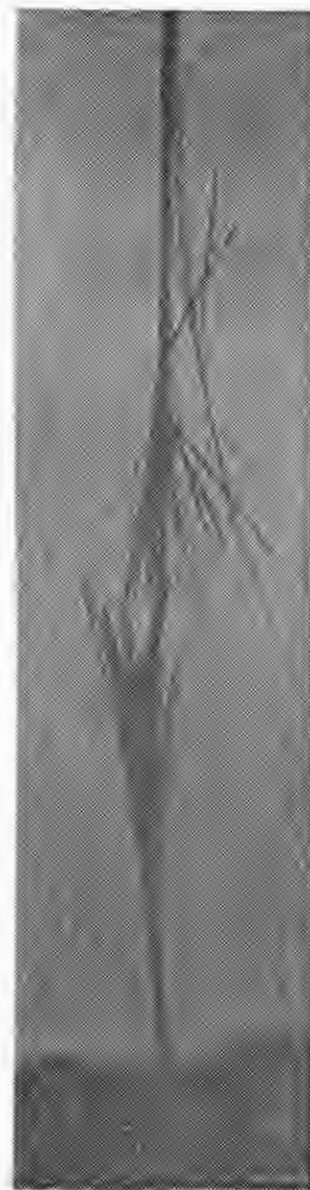
Figure 22 - TENSILE TEST LOADING-TO-FAILURE SEQUENCE

In the specimens tested that contained holes, which included damaged and drilled holes, the fracture line was at the hole or within the influence area of the hole. By passing a $+45^\circ$ line and a -45° line through the center of the hole and noting where these lines intersected the edge of the specimens, the influence area of the hole could be described. All the lines of failure passed within this 1.5 inch-by-1.5 inch area.
